# ANNUAL REPORT FOR 2010

**Unnamed Tributary to Lumber  
River Mitigation Site  
Robeson County  
TIP No. R-0513WM**

Prepared By:  
Natural Environment Unit & Roadside Environmental Unit  
North Carolina Department of Transportation  
December 2010

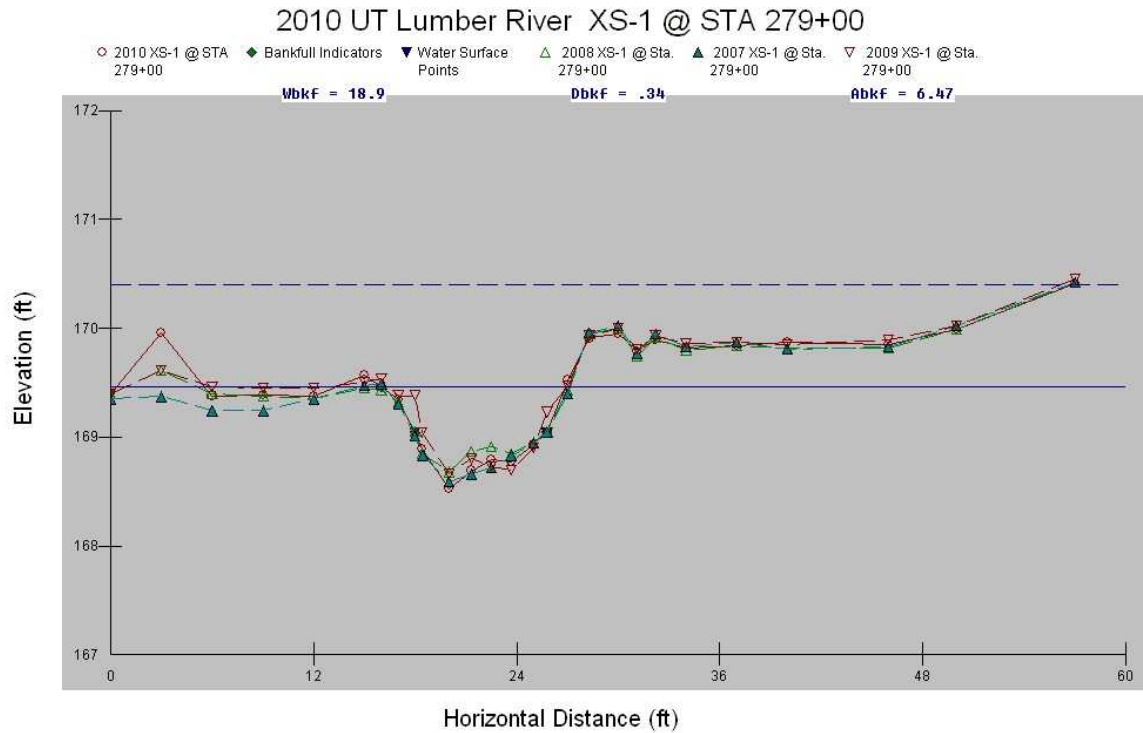
Cross-Section #1 (Riffle) Abbreviated Morphological Summary					
	2008	2009	2010	2011	2012
Bankfull Width (ft)	11.0	11.20	10.90		
Bankfull Mean Depth (ft)	0.45	0.54	0.55		
Width/Depth Ratio	24.44	20.74	19.73		
Bankfull Cross Sectional Area (ft <sup>2</sup> )	4.98	6.03	5.92		
Maximum Bankfull Depth (ft)	0.75	0.88	0.94		
Width of the Floodprone Area (ft)	53	56	56.83		
Entrenchment Ratio	4.83	5.05	5.24

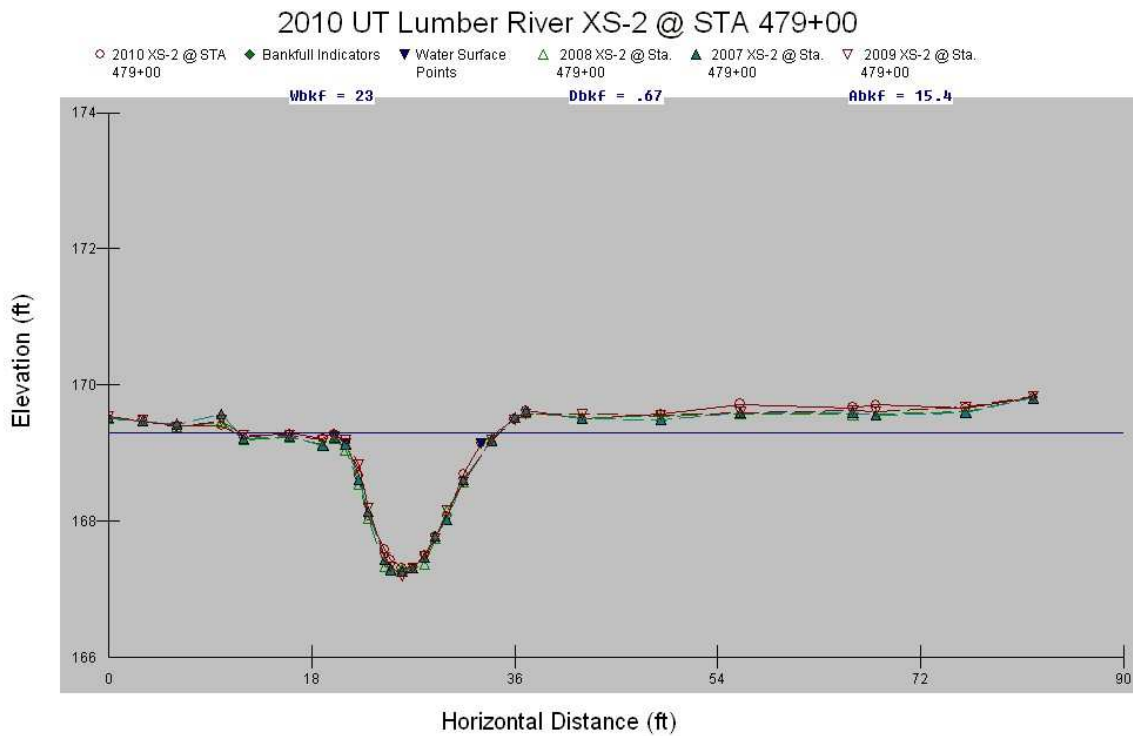
Cross-Section #2 (Pool) Abbreviated Morphological Summary*					
	2008	2009	2010	2011	2012
Bankfull Cross Sectional Area (ft <sup>2</sup> )	15.31	15.05	15.12		
Maximum Bankfull Depth (ft)	1.92	2.06	1.97		
Bankfull Mean Depth (ft)	1.09	0.84	1.06		
Bankfull Width (ft)	14.0	17.92	14.25

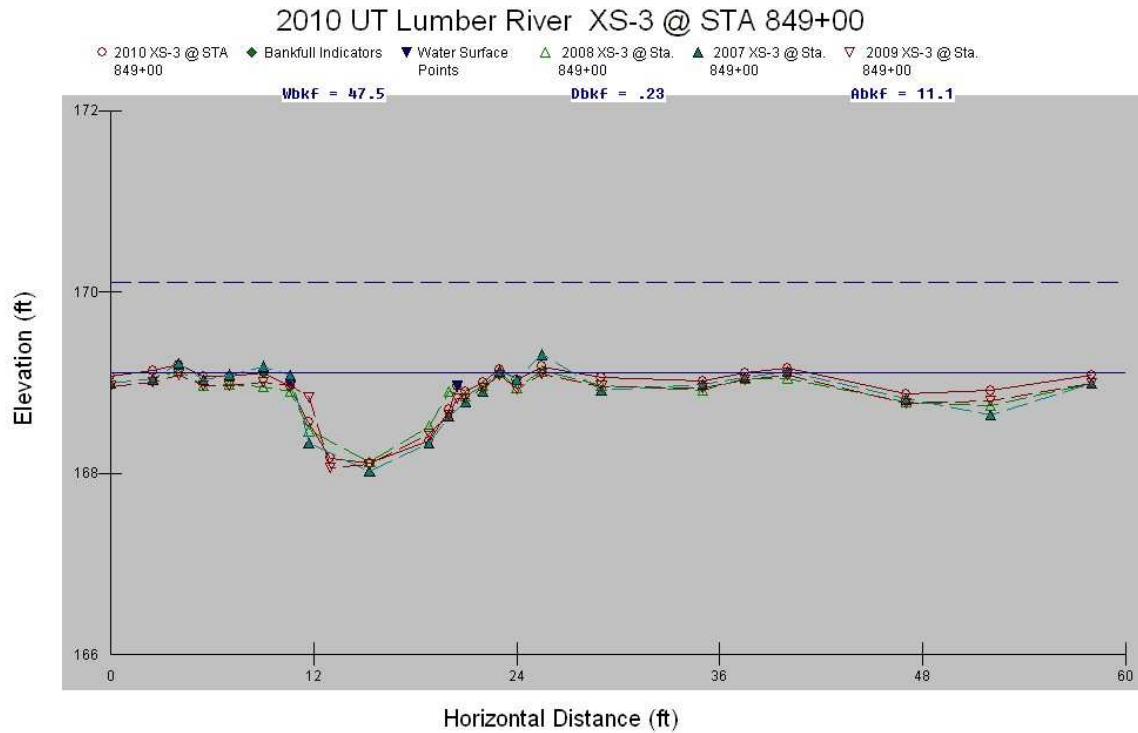
Cross-Section #3 (Riffle) Abbreviated Morphological Summary					
	2008	2009	2010	2011	2012
Bankfull Width (ft)	9.4	11.40	13.71		
Bankfull Mean Depth (ft)	0.49	0.53	0.57		
Width/Depth Ratio	19.18	21.51	24.05		
Bankfull Cross Sectional Area (ft <sup>2</sup> )	4.64	6.06	7.87		
Maximum Bankfull Depth (ft)	0.77	0.91	1.00		
Width of the Floodprone Area (ft)	58	58	58		
Entrenchment Ratio	6.17	5.09	4.23

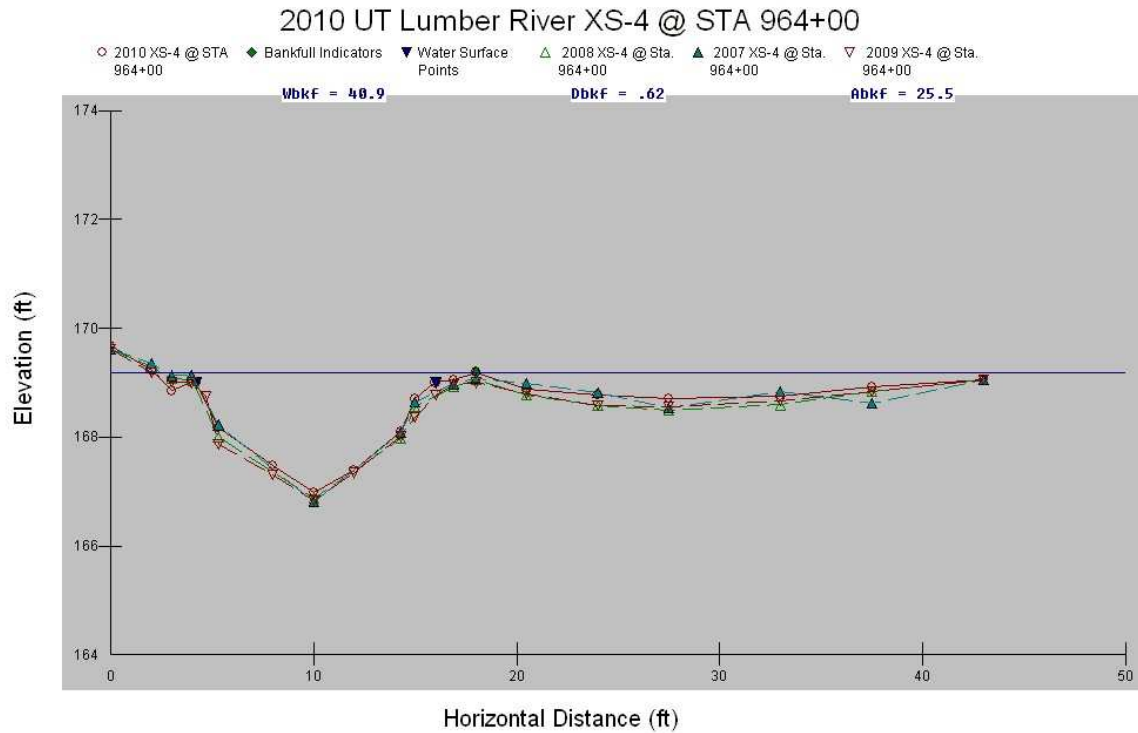
Cross-Section #4 (Pool) Abbreviated Morphological Summary*					
	2008	2009	2010	2011	2012
Bankfull Cross Sectional Area (ft <sup>2</sup> )	16.42	17.90	17.16		
Maximum Bankfull Depth (ft)	2.17	2.29	2.21		
Bankfull Mean Depth (ft)	1.17	1.28	1.08		
Bankfull Width (ft)	14.0	14.0	15.92

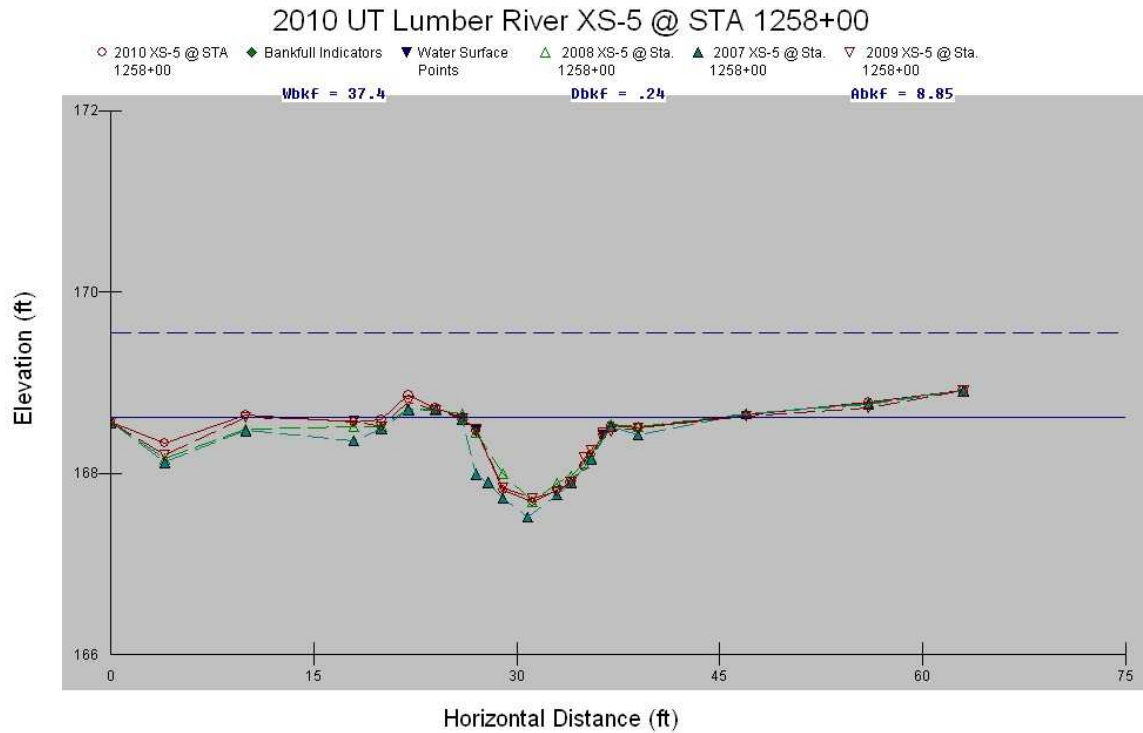
Cross-Section #5 (Riffle) Abbreviated Morphological Summary					
	2008	2009	2010	2011	2012
Bankfull Width (ft)	10.45	9.31	11.00		
Bankfull Mean Depth (ft)	0.49	0.49	0.59		
Width/Depth Ratio	21.33	19.0	18.64		
Bankfull Cross Sectional Area (ft <sup>2</sup> )	5.11	4.52	6.51		
Maximum Bankfull Depth (ft)	0.85	0.73	0.93		
Width of the Floodprone Area (ft)	63	63	63		
Entrenchment Ratio	6.03	6.77	5.73

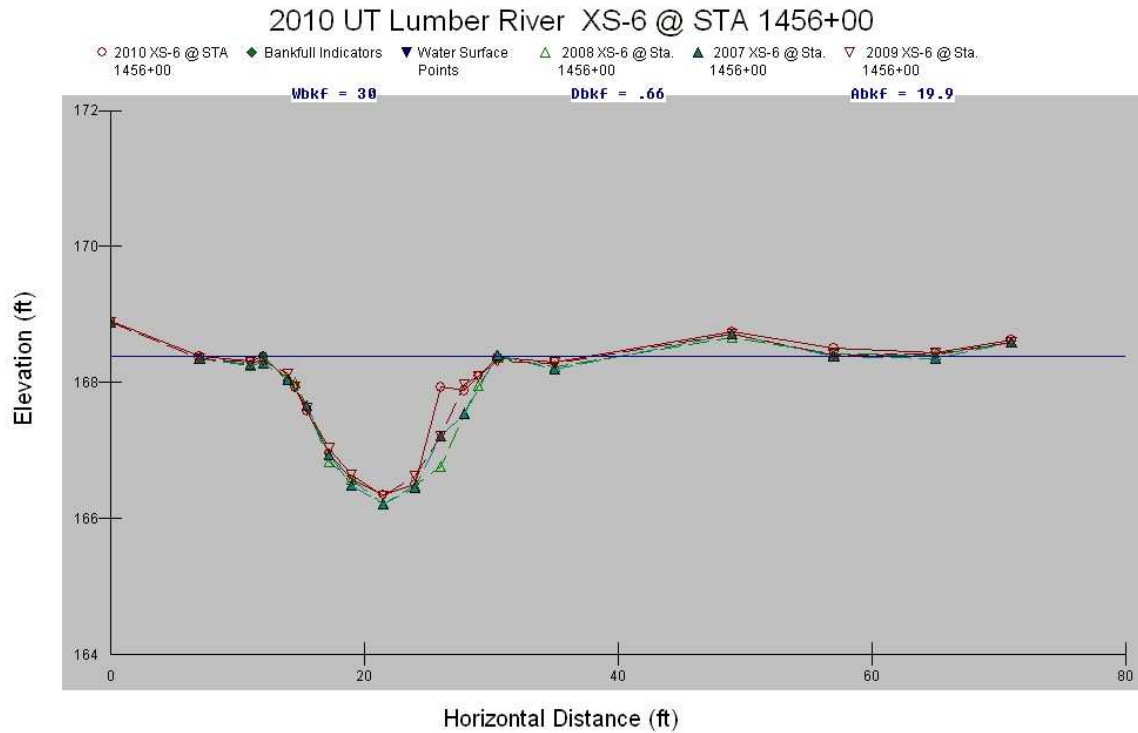
Cross-Section #6 (Pool) Abbreviated Morphological Summary*					
	2008	2009	2010	2011	2012
Bankfull Cross Sectional Area (ft <sup>2</sup> )	22.71	19.06	19.54		
Maximum Bankfull Depth (ft)	2.15	1.99	2.03		
Bankfull Mean Depth (ft)	1.23	1.03	1.06		
Bankfull Width (ft)	18.50	18.50	18.45

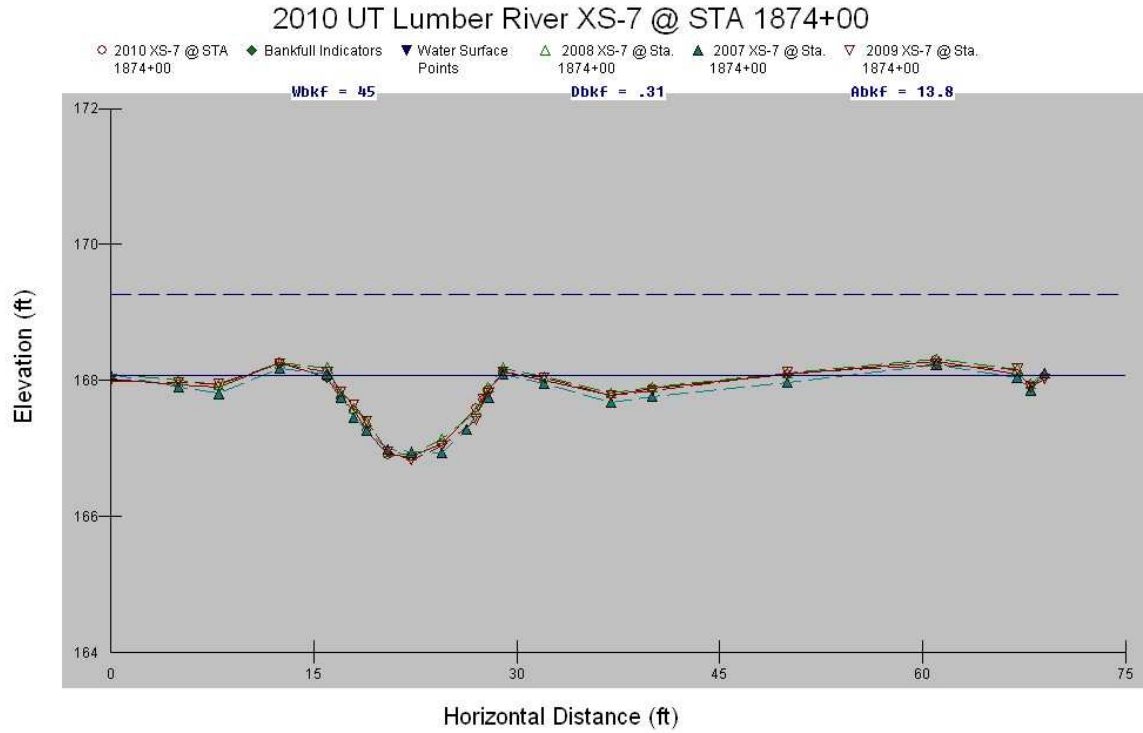
Cross-Section #7 (Riffle) Abbreviated Morphological Summary					
	2008	2009	2010	2011	2012
Bankfull Width (ft)	13.0	13.0	12.8		
Bankfull Mean Depth (ft)	0.8	0.79	0.75		
Width/Depth Ratio	16.25	16.46	17.07		
Bankfull Cross Sectional Area (ft <sup>2</sup> )	10.4	10.26	9.66		
Maximum Bankfull Depth (ft)	1.28	1.30	1.19		
Width of the Floodprone Area (ft)	69	69	69		
Entrenchment Ratio	5.31	5.31	5.39

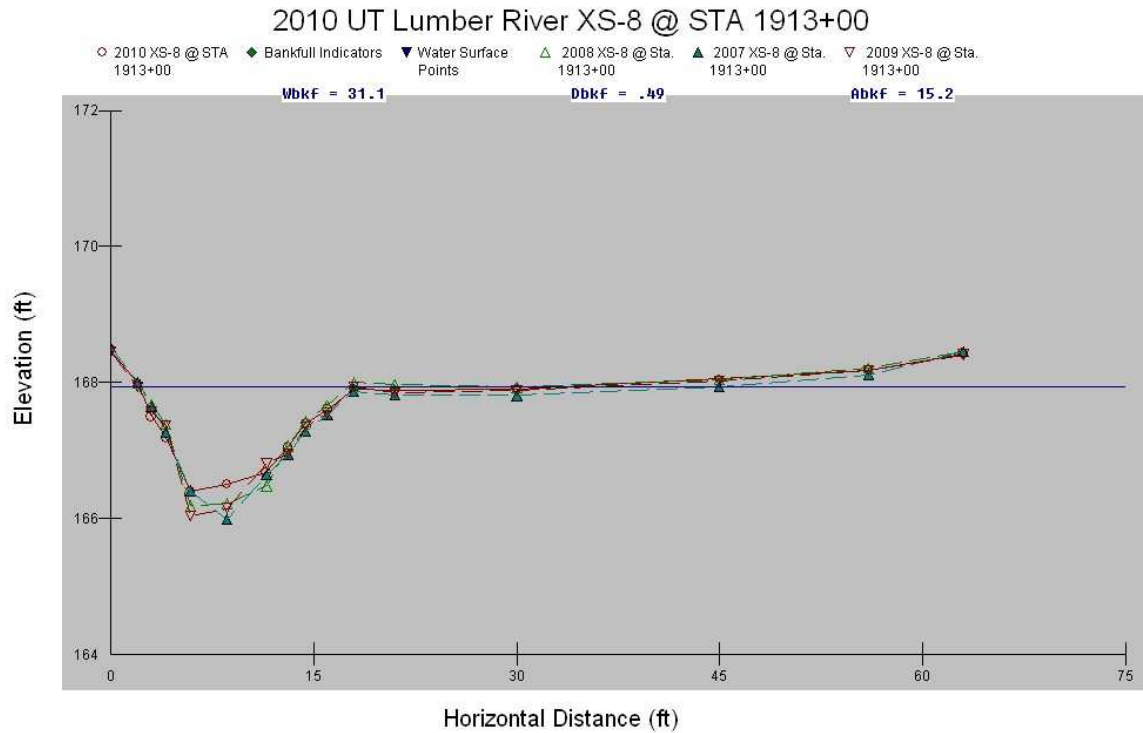
Cross-Section #8 (Pool) Abbreviated Morphological Summary*					
	2008	2009	2010	2011	2012
Bankfull Cross Sectional Area (ft <sup>2</sup> )	16.5	16.01	14.56		
Maximum Bankfull Depth (ft)	1.81	1.90	1.54		
Bankfull Mean Depth (ft)	1.03	1.0	0.92		
Bankfull Width (ft)	16	16	15.9

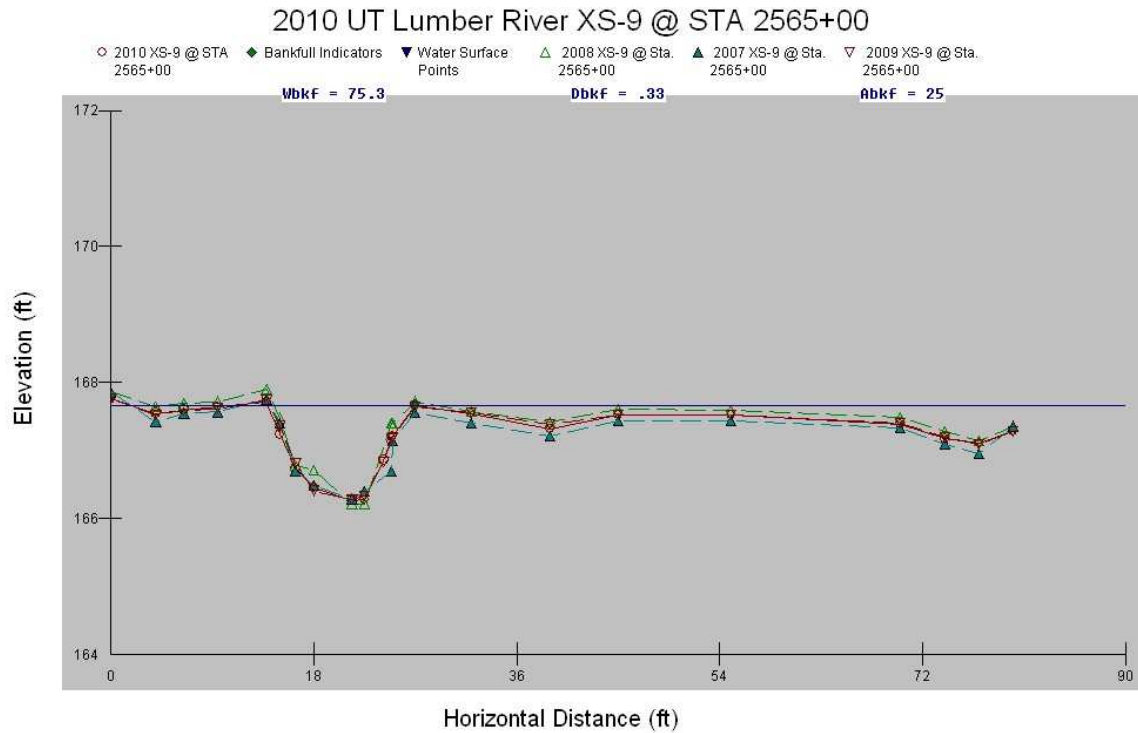
Cross-Section #9 (Pool) Abbreviated Morphological Summary*					
	2008	2009	2010	2011	2012
Bankfull Cross Sectional Area (ft <sup>2</sup> )	10.89	11.15	11.74		
Maximum Bankfull Depth (ft)	1.51	1.36	1.40		
Bankfull Mean Depth (ft)	0.86	0.87	0.90		
Bankfull Width (ft)	12.61	12.88	13.10

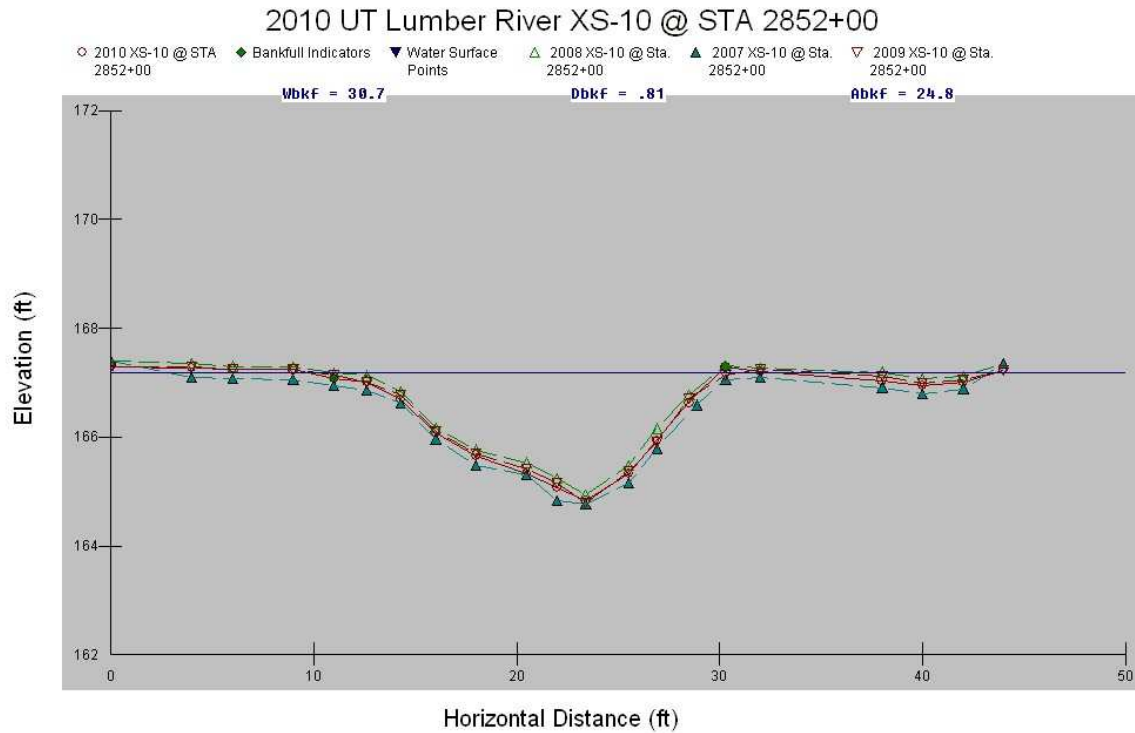
Cross-Section #10 (Pool) Abbreviated Morphological Summary*					
	2008	2009	2010	2011	2012
Bankfull Cross Sectional Area (ft <sup>2</sup> )	23.31	21.96	23.56		
Maximum Bankfull Depth (ft)	2.37	2.34	2.35		
Bankfull Mean Depth (ft)	1.1	1.14	1.16		
Bankfull Width (ft)	21.23	19.3	20.27

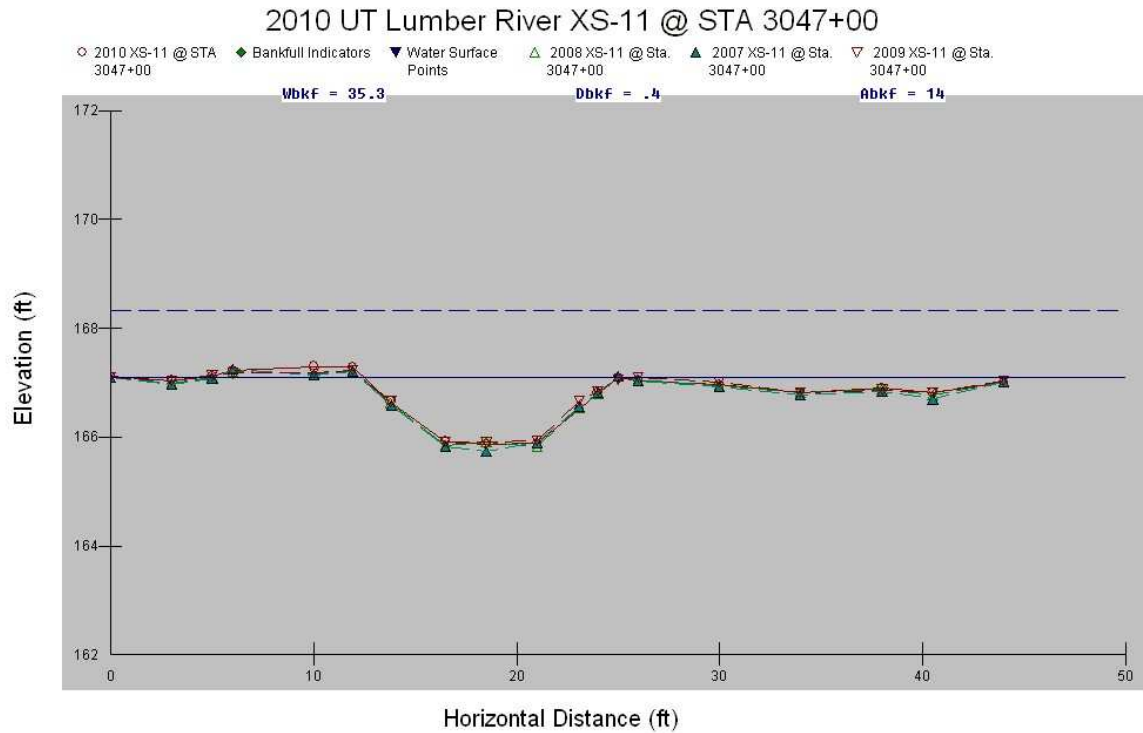
Cross-Section #11 (Riffle) Abbreviated Morphological Summary					
	2008	2009	2010	2011	2012
Bankfull Width (ft)	12.76	12.57	12.56		
Bankfull Mean Depth (ft)	0.86	0.76	0.83		
Width/Depth Ratio	14.84	16.54	15.13		
Bankfull Cross Sectional Area (ft <sup>2</sup> )	10.93	9.54	10.38		
Maximum Bankfull Depth (ft)	1.3	1.16	1.23		
Width of the Floodprone Area (ft)	44	44	44		
Entrenchment Ratio	3.45	3.50	3.50
